# Home Inspection Report

12 Sample Avenue  
Rancho Mirage, CA  
October 25, 2006  
Prepared for: John and Mary Buyer

Performed by  
Complete Home Inspections Inc.  
PO Box 10314  
Palm Desert, CA 92255-0314  
(760) 641-1374  
[bkirstein@completehomeinspections.net](mailto:bkirstein@completehomeinspections.net)  
[www.completehomeinspections.net](http://www.completehomeinspections.net)

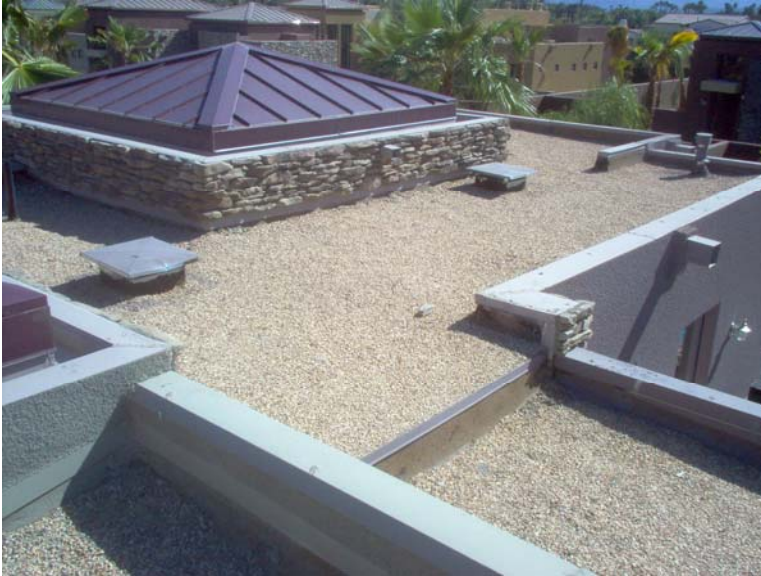
Typical roof view.

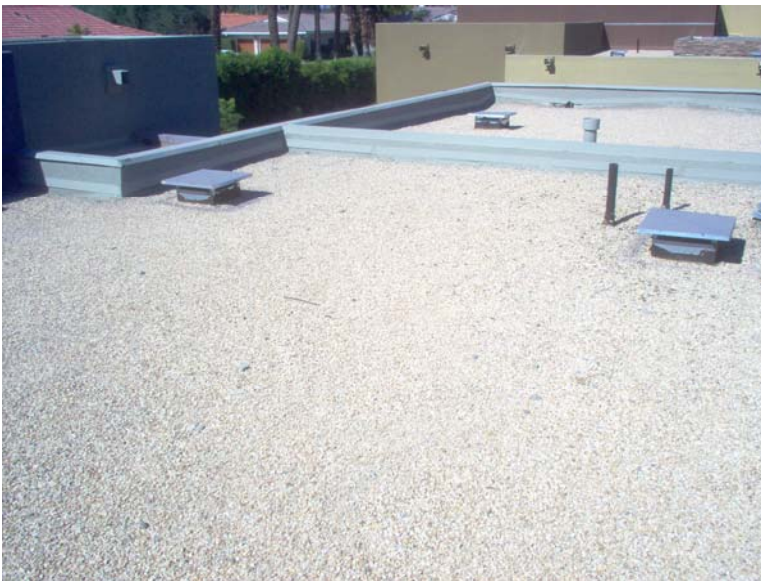
Another roof view.

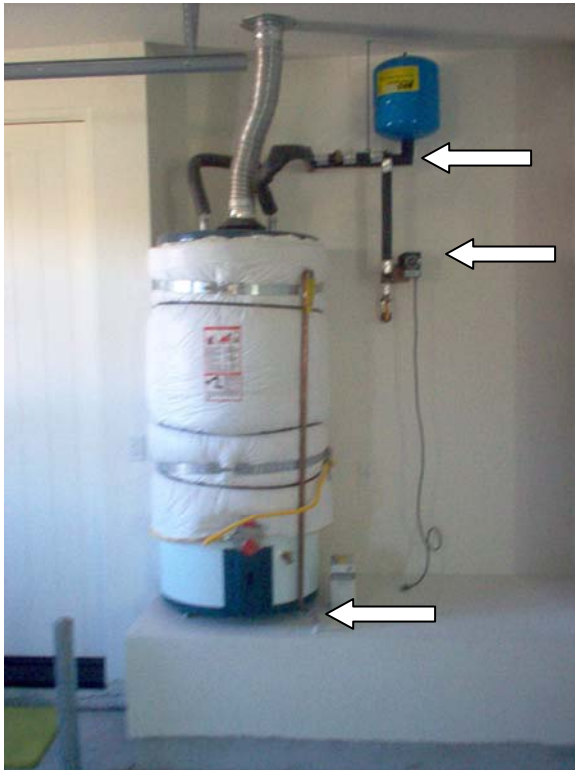
- 3) We could not get the hot water circulation pump to run.
- 4) The hot water heater TPRV drain piping does not end in a visible location.
- 5) The copper piping needs to be braced where it comes through the wall by the water heater and diaphragm.
- 6) Some of the anti-scalding mixing valves in the shower do not allow the water to get hot. For example, there are two heads in the master shower with different temperatures. Recommend for all shower valves to be checked and adjusted.

View of water heater. Arrows indicate top: area needs bracing, middle: recirculation pump, below: PTRV piping.

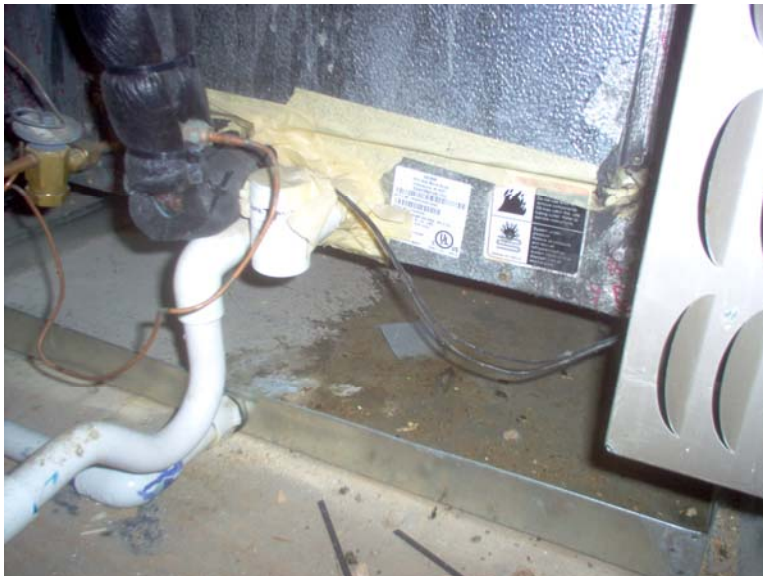
- 11) There are two HVAC units mounted in the attic. The one on the right has quite a bit of oil in the drip pan. The left side has some oil below as well. Recommend for the units to be checked to make sure there isn't some problem such as a leaking bearing seal or some other problem. We don't normally see oil like this.
- 12) Inspector recommends servicing of all three units including new filters and cleaning of condensing units. This is normal maintenance but it does appear to be due.

Oil staining at attic mounted HVAC unit.
